**Concentrated Animal Feeding Operation
NPDES Inspection Report**
Facility Name: Big Island Dairy
NPDES Permit No.: Not Permitted

Date and Time: December 14, 2016 **Entry:** 10:00 a.m. **Exit:** 4:45 p.m.

Facility Name: Big Island Dairy

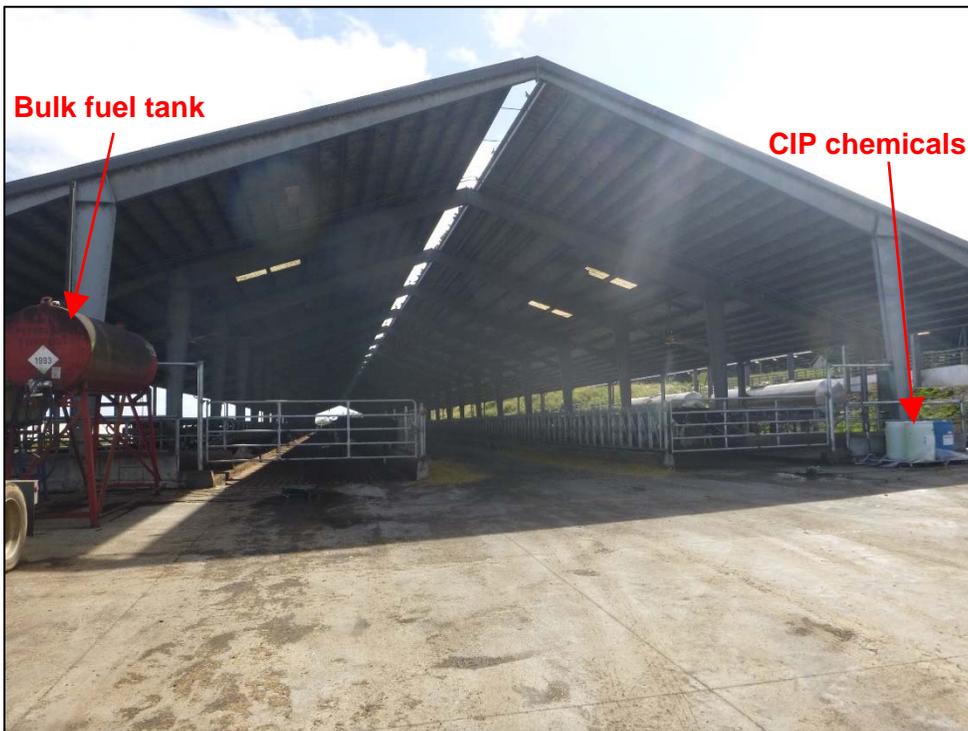
5. During the inspection, I observed 4 bulk gasoline and diesel aboveground fuel storage tanks: 2 at the lower freestall barn and 2 at the maintenance building (refer to Photograph 4). Based on the approximate size of the aboveground storage tanks, it appeared that the Facility had the potential to store greater than 1,320 gallons of fuel onsite, and as such, may be subject to spill prevention control and countermeasure rule specified in 40 CFR Part 112.12. The Facility should ensure that the bulk fuel aboveground storage tanks are either a double-walled tank, or stored within secondary containment to minimize the possibility of a leak or spill.

Photograph 4. View of the Facility's newly constructed lower 1,000-cow freestall barn. Note the bulk fuel tank and CIP chemicals. Photo by A. D'Angelo; 12/14/16.

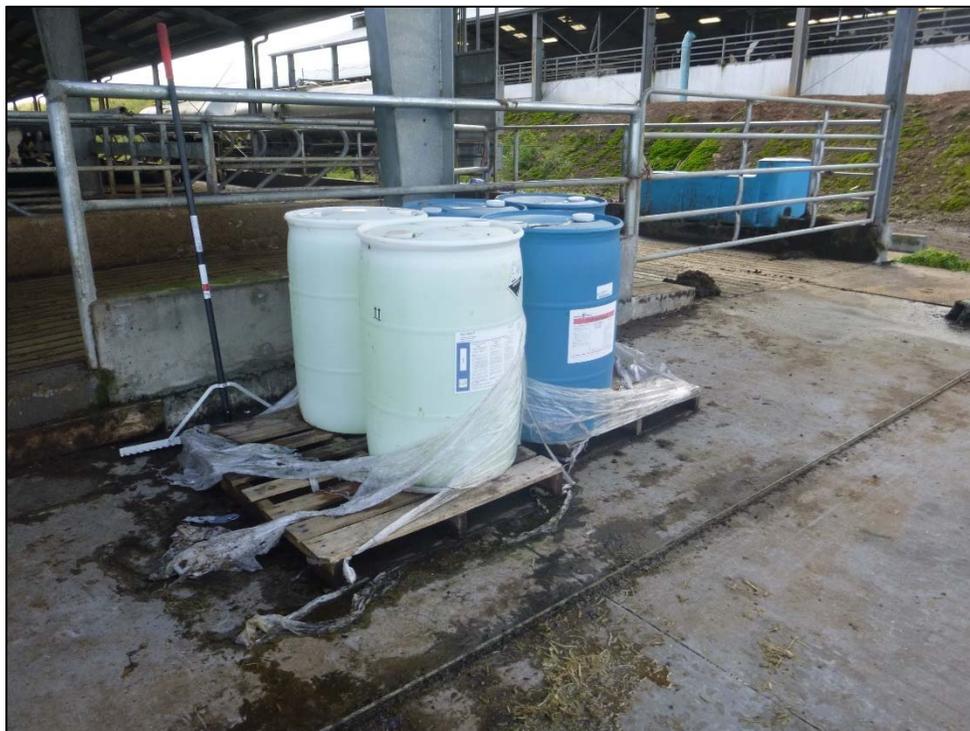
tour, I observed multiple 55-gallon drums of caustic detergent and acid (incompatible chemicals) stored together on a pallet, outdoors without secondary containment (refer to Photographs 4 and 10). Milking cows are directed through a copper sulfate hoof bath when entering and exiting the milking barn to prevent spread of disease and bacteria in an area of high cow traffic (refer to Photograph 11). Milk product is stored in two 20,000-gallon milk silos. Well water used for general dairy operations is stored in a 17,000-gallon aboveground tank located adjacent to the milk silos.

4. During the inspection, I observed chemical storage practices that may present hazardous conditions for Facility employees and livestock. Specifically, I observed multiple 55-gallon drums of caustic detergent and acid stored together on pallets, outdoors without secondary containment (refer to Photographs 4 and 10). After the inspection, I reviewed the Safety Data Sheets (SDSs) for the two CIP chemicals and verified that the chemicals were incompatible based on their pH: Solution® chlorinated alkaline detergent 11.5 standard pH units; CIP Acid Cleaner 2.4 standard pH units. Mr. Duff stated that due to a lack of storage space, surplus CIP chemicals are stored on wooden pallets outside each of the freestall barns. Due to the incompatibility of acids and bases, uncontained drums of the two CIP chemicals stored adjacent to each other can create environmental and health hazards in the event of a spill or leak. This concern is elevated due to the truck/tractor traffic at the freestall barns associated with feed and bedding operations.

Photograph 10. View of two 55-gallon drums of acid and two 55-gallon drums of caustic detergent used in the milking barn CIP system. The drums were stored outside, without overhead coverage or containment, and in close proximity to each other. Photo by A. D'Angelo; 12/14/16.

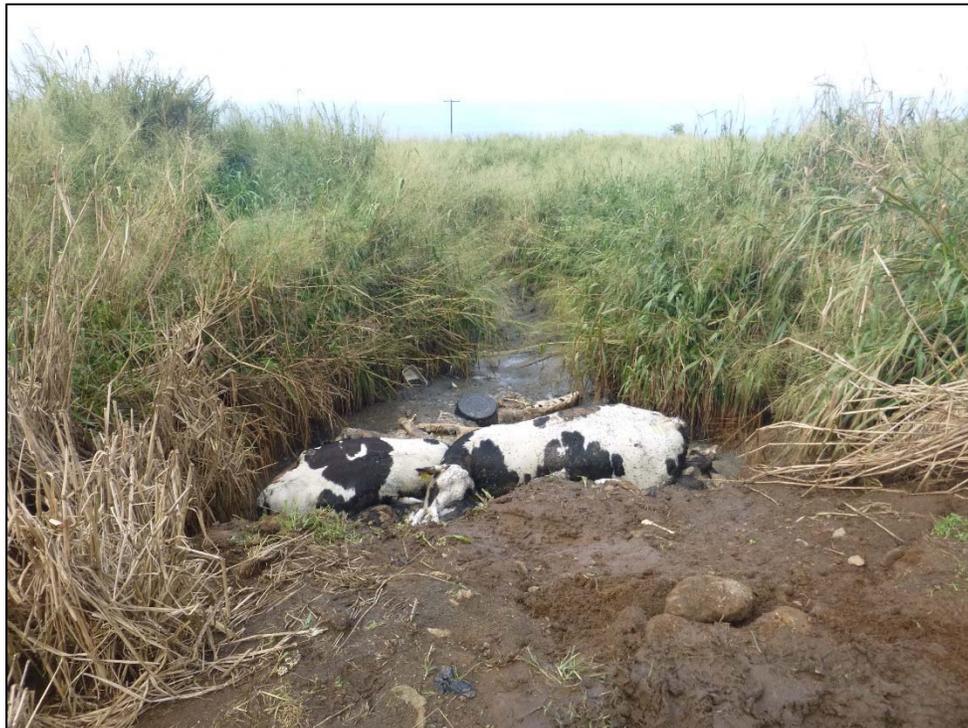
The BID Representatives stated that mortalities are buried onsite. The mortality burial pit that was in use at the time of the inspection was located in an existing gulch located between the covered manure separation cells access roadway and the newly constructed 2.5 million-gallon lower wastewater lagoon (refer to Photograph 14). Mr. Duff stated that any storm water runoff that comes into contact with the open mortality burial pit would sheet flow into the lower lagoon.

Photograph 14. View, facing northeast, of the Facility's active mortality burial pit, which was located near the manure separation cells, in an existing gulch that drains into the lower lagoon. Photo by A. D'Angelo; 12/14/16.

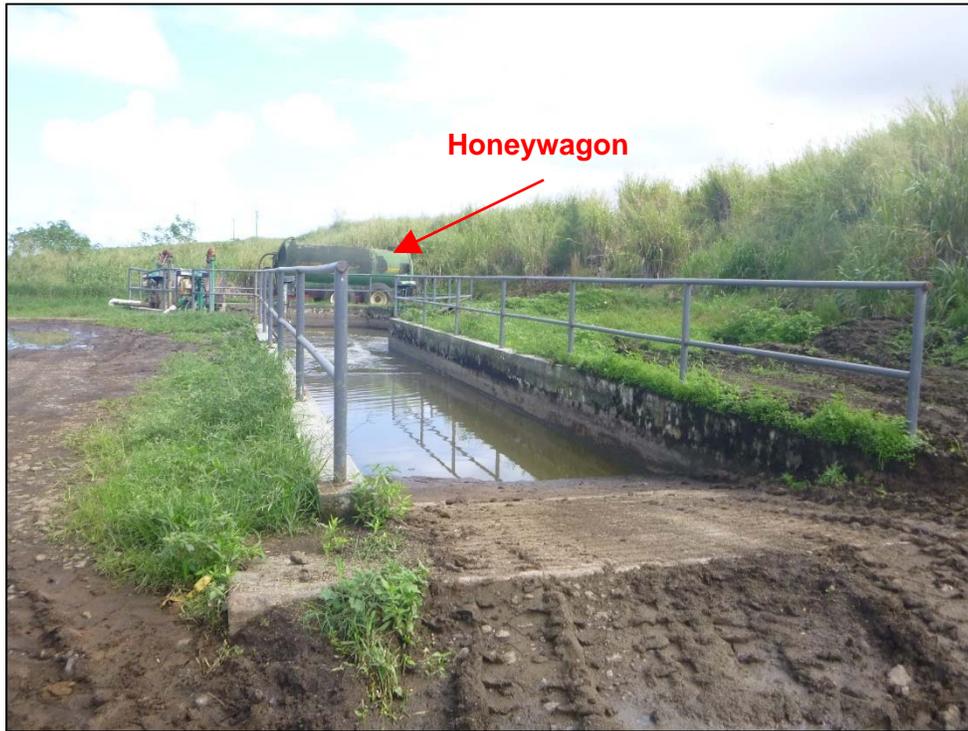
- Steep topography of the BID property, and
 - High annual rainfall amount.
3. During the inspection, I observed a potential for pollutants from the Facility's manure composting operations to contaminate storm water runoff. The manure composting building is located near the origin of Alaialoa Gulch (refer to Figure 3). Storm water runoff from the manure composting building, and uncovered concrete cow bedding loading area appears to most likely flow into the upgradient reach of Alaialoa Gulch. As previously stated, during the visit to the manure composting building, I observed a tractor actively loading a trailer with cow bedding (refer to Photographs 15 through 19, and 21).

Photograph 15. View of the Facility's manure composting building collection pit. Waste streams from the freestall barns, calf barn, and milking barn gravity flow into this collection pit. Note the honeywagon stored behind the collection pit. Photo by A. D'Angelo; 12/14/16.

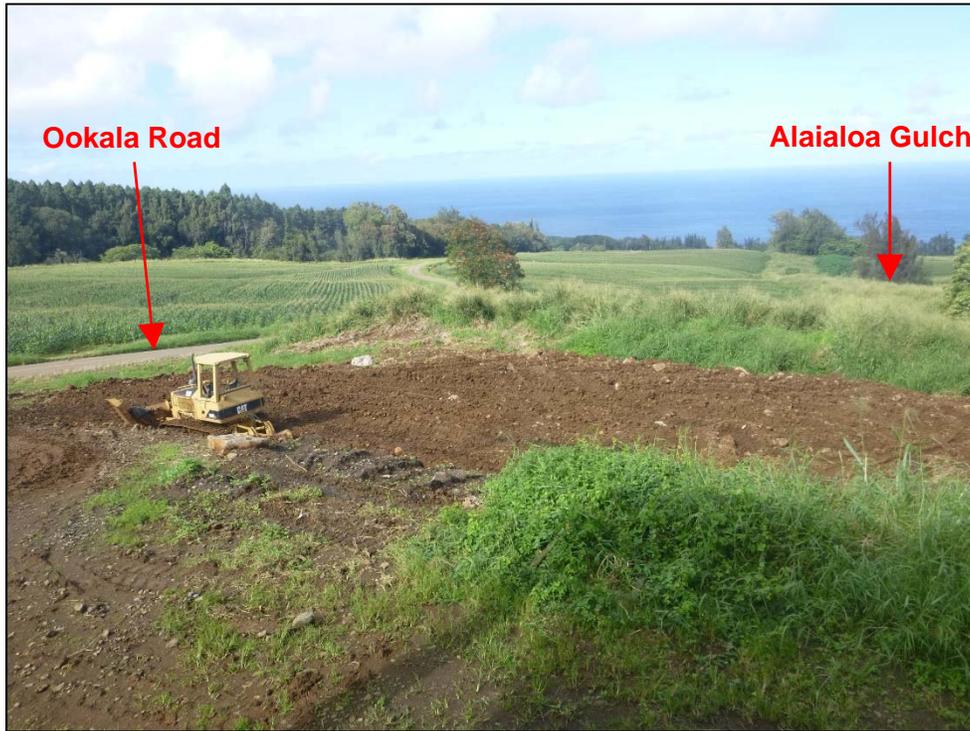
Photograph 21. View, facing north, of a disturbed area near Ookala Road. This area will be paved to store the honeywagon shown in Photographs 15 and 20. I observed a vegetated buffer between the disturbance and Alaialoa Gulch. Photo by A. D’Angelo; 12/14/16.

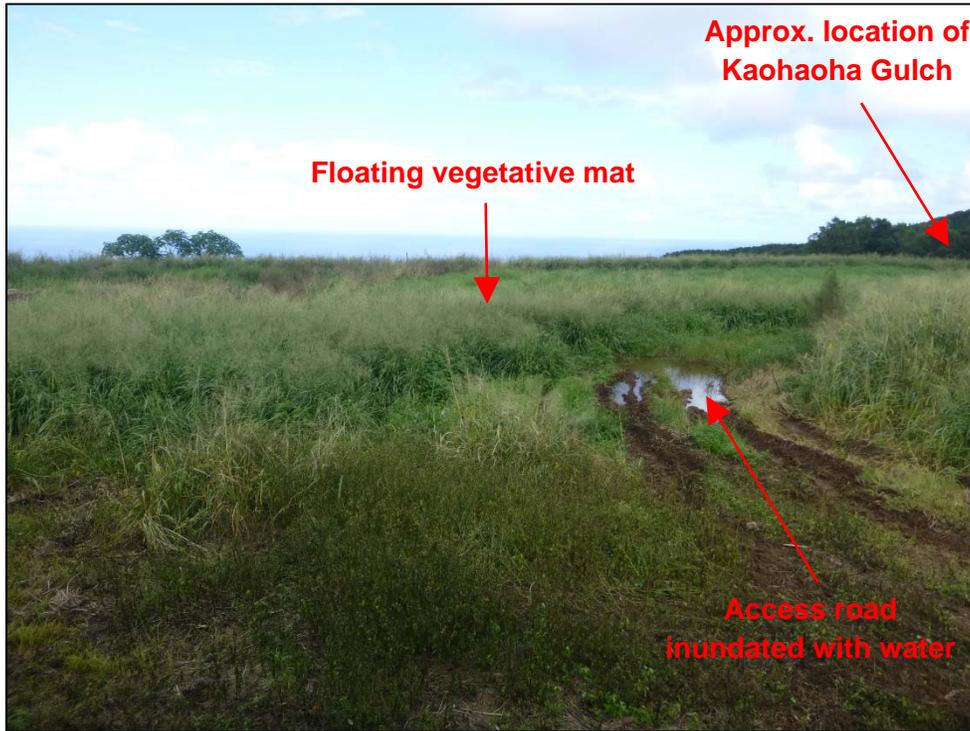
At the time of the inspection, Mr. Kurano and I observed the large vegetative mat on the surface of the upper lagoon (refer to Photograph 25). Mr. Duff stated that the vegetative mat has been present since the property was purchased in 2012, and that it has prevented Facility personnel from accessing the lagoon or identifying the depth of accumulated solids. As such, Mr. Duff stated that the upper lagoon had not been cleaned since at least 2012, and that he was unaware of the depth of solids in the lagoon or the exact date of the last cleaning event. Mr. Kurano and I observed that the upper lagoon was not equipped with a depth marker at the time of the inspection.

During the inspection, I observed algae growth and standing water in the lower lagoon's overflow spillway (refer to Photographs 32, 33, and 35). Mr. Duff stated that he did not believe that the standing water present in the lower lagoon overflow spillway was from the lagoon, but from storm water runoff from upgradient land caused by recent heavy rainfall. This was inconsistent with a statement made by the BID Representatives during the opening conference, when they stated that the lagoons do not receive storm water runoff. The upper lagoon is located directly upgradient from the lower lagoon and overflow spillway (refer to Photograph 27). As previously stated, Mr. Duff informed Mr. Kurano and I that a large floating vegetative mat on the surface of the upper lagoon prevented Facility employees from accessing the lagoon for cleaning, and as such, the upper lagoon had not been cleaned since the current owners purchased the Facility in 2012. At the time of the inspection, the upper lagoon was not equipped with a depth marker. Additionally, Mr. Duff stated that the majority of flow from the upper lagoon is transferred to the lower lagoon via the east connection pipe. At the time of the inspection, an access road that runs along the south side of the upper lagoon was inundated with water; therefore, the perimeter of the upper lagoon, including the east side of the lagoon that abuts Kaohaoha Gulch was inaccessible (refer to Photograph 25).

- Potential overloading of solids in the upper lagoon,
 - Possibility of storm water runoff from upgradient areas entering the lagoons,
 - Inaccessibility of the upper lagoon's east abutting side to Kaohaoha Gulch (refer to Photograph 25),

Photograph 25. View, facing east, of the upper lagoon which contained a floating vegetative mat. An access road along the south side of the lower lagoon was innundated with water. Photo by A. D'Angelo; 12/14/16.

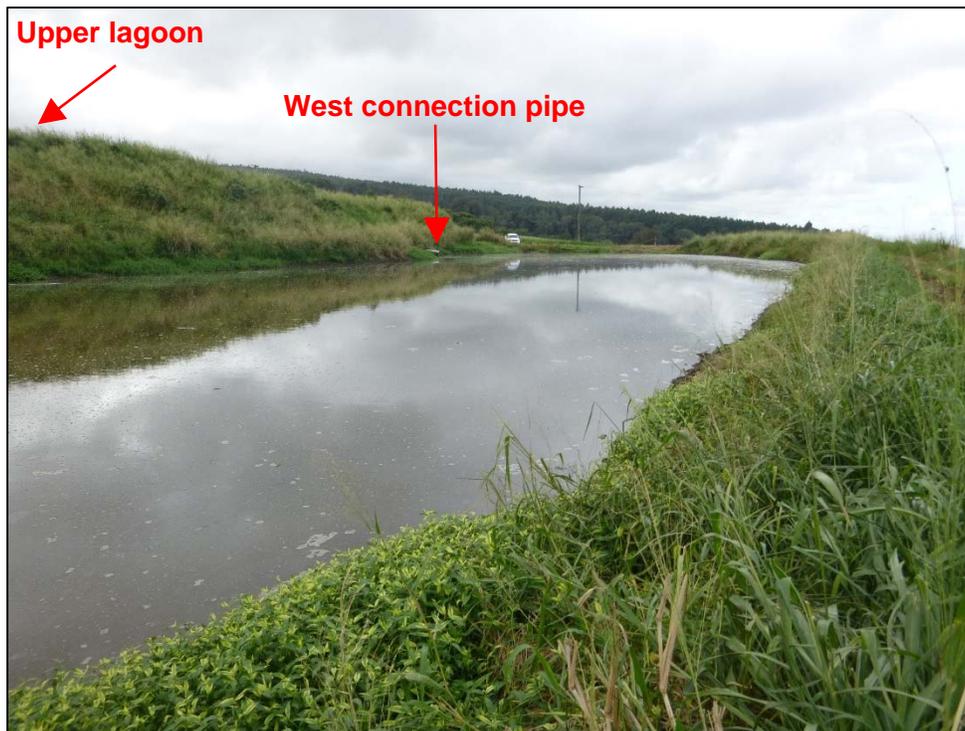
Photograph 26. View, facing west, of the lower lagoon. The lagoon was near capacity at the time of the inspection and was not equipped with a depth marker. Photo by A. D'Angelo; 12/14/16.

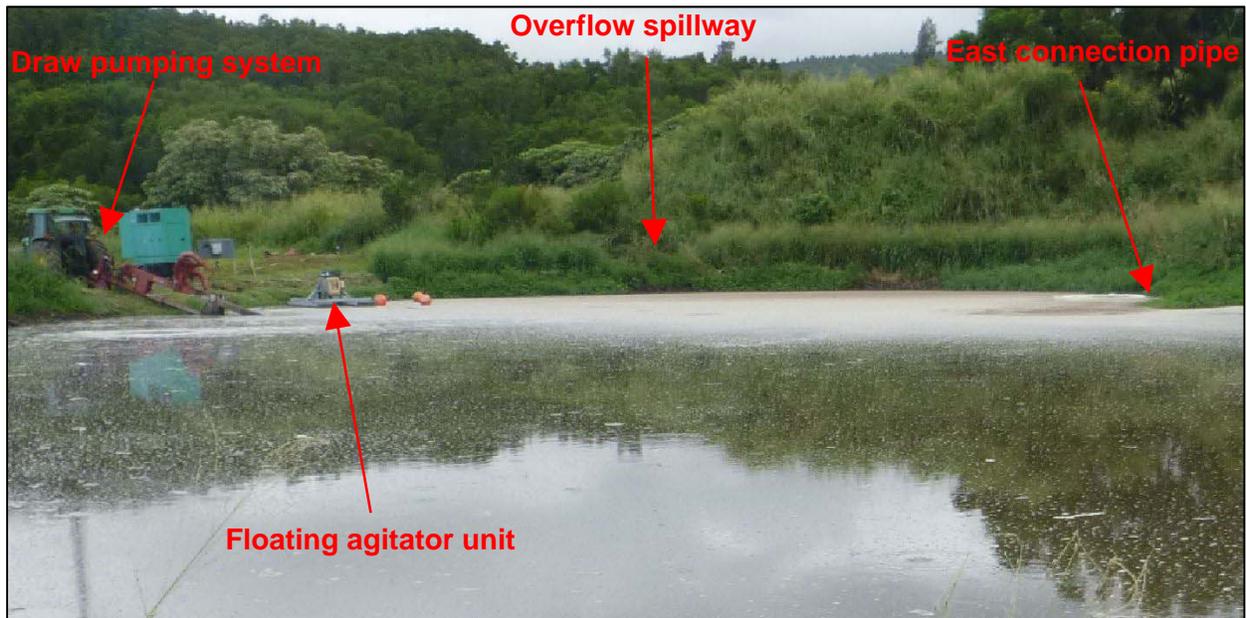
Additionally, the lower lagoon contained a floating agitator unit which was used to agitate and suspend manure solids in the lower lagoon prior to engaging the draw pumping system for irrigation (refer to Photograph 28). Due to the minimal freeboard in the lower lagoon, there exists a possibility of spillover from lagoon into the overflow spillway due to agitation activities that may occur near the overflow spillway.

Photograph 28. Zoomed-in version of Photograph 27, showing the floating agitator unit, draw pumping system, and overflow spillway of the lower lagoon. Photo by A. D’Angelo; 12/14/16.

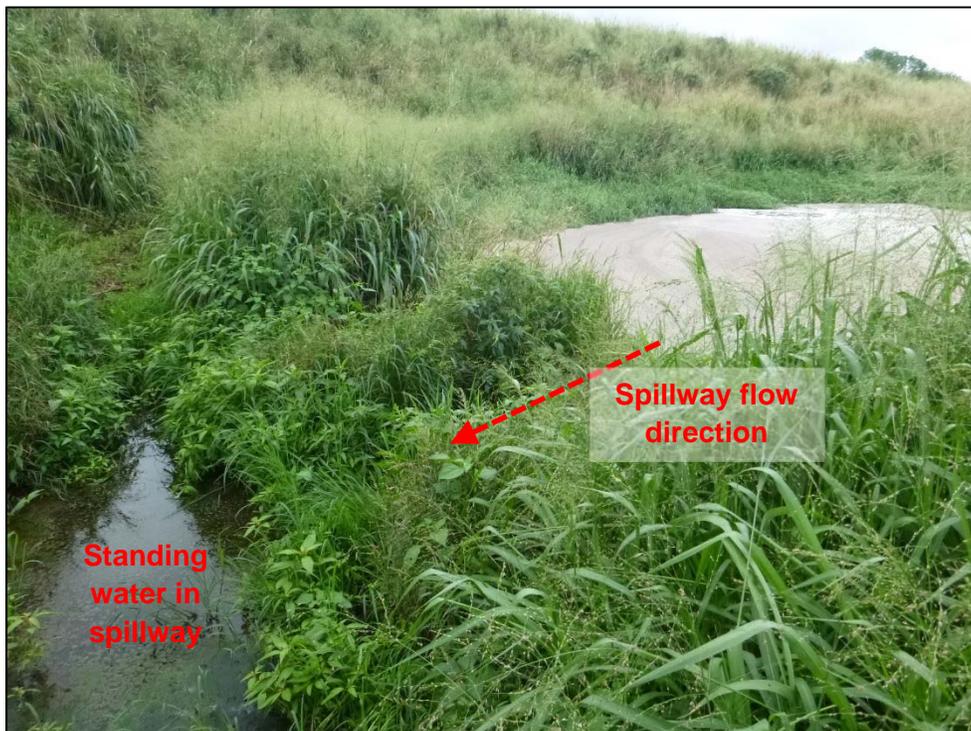
Photograph 32. View, facing southwest, of the lower lagoon overflow spillway. Note the presence of algae growth and standing water in the overflow spillway. Photo by A. D'Angelo; 12/14/16.

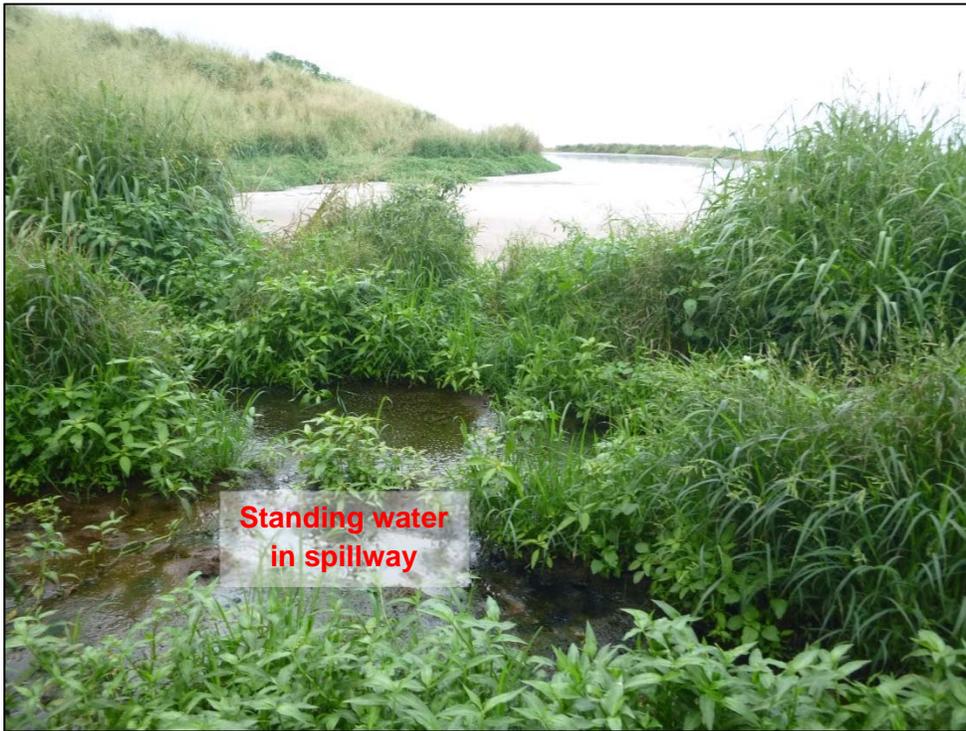
Photograph 33. View of algae growth and standing water in the lower lagoon overflow spillway. Photo by A. D'Angelo; 12/14/16.

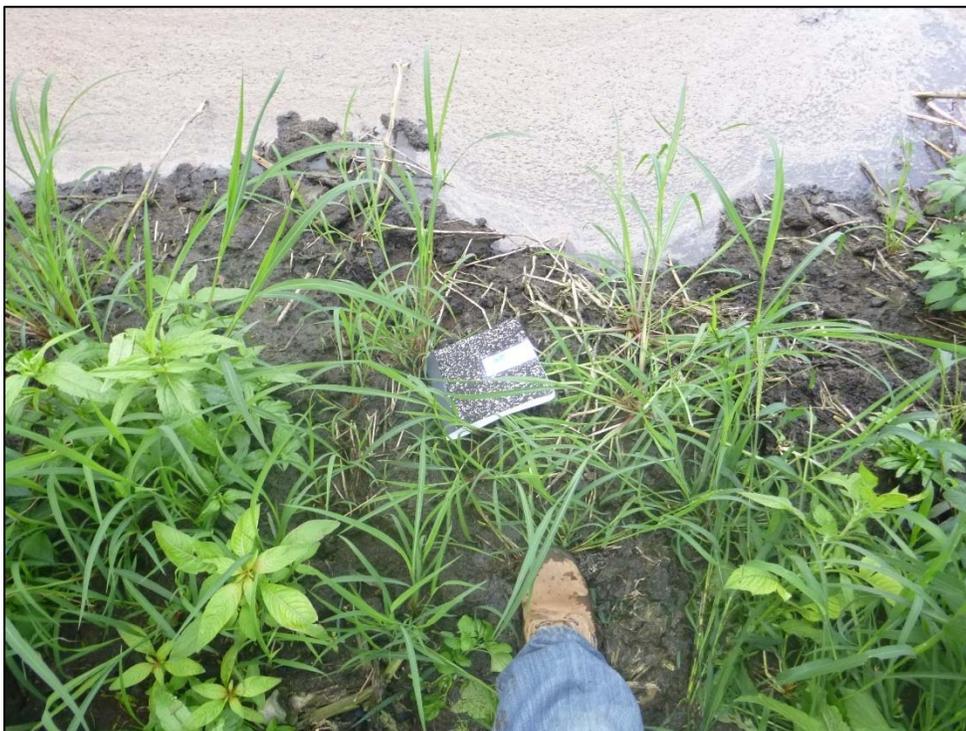
Photograph 34. Standing on the lower lagoon overflow spillway, I estimated the freeboard of the lagoon at approximately twelve inches (note the notebook for reference). Photo by A. D'Angelo; 12/14/16.

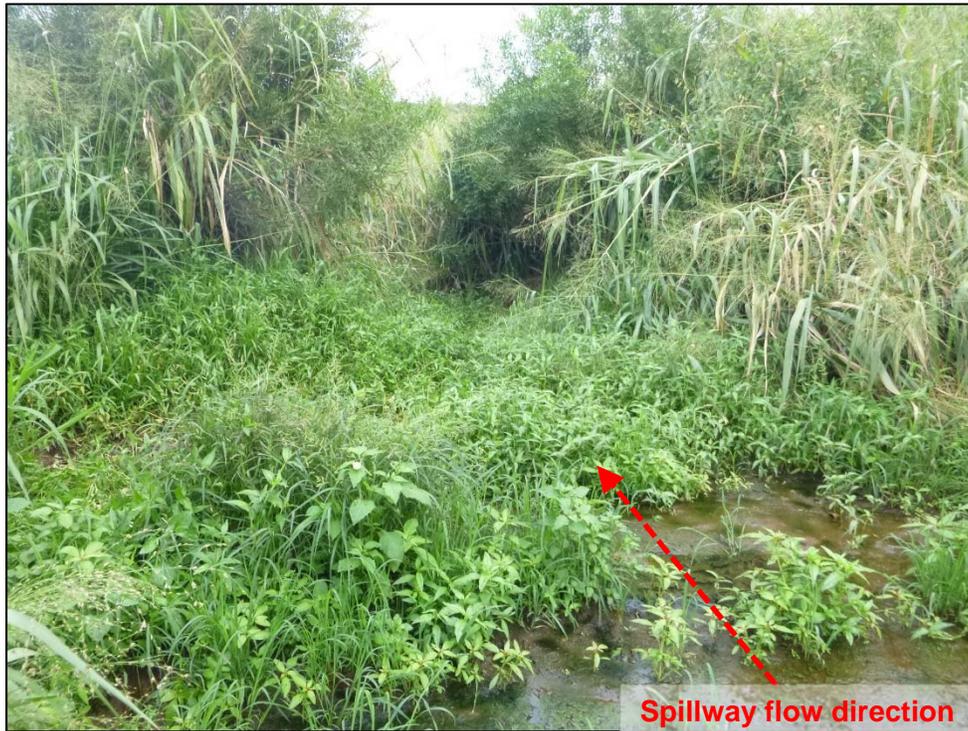
Photograph 35. View, facing southeast from the lower lagoon overflow spillway, down the vegetated channel that connects the lagoon to Kaohaoha Gulch. Photo by A. D'Angelo; 12/14/16.

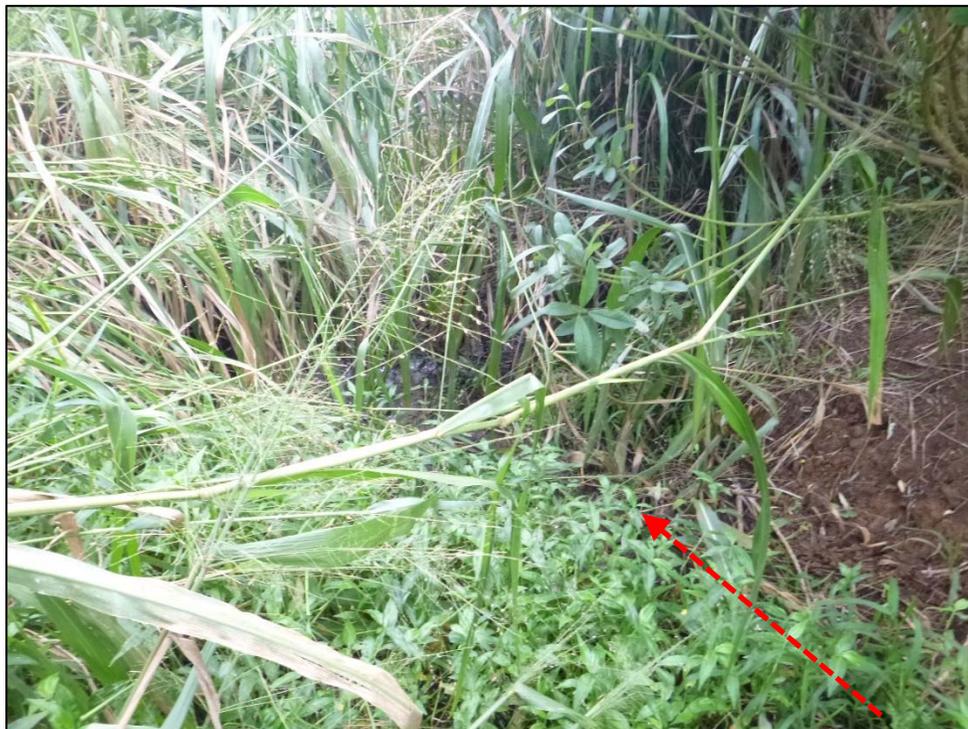
During the opening conference, I asked the BID Representatives if the newly constructed lower lagoon was lined and if it was equipped with an overflow spillway. The BID Representatives did not believe the lower lagoon contained a liner and were initially unaware if the lower lagoon contained a spillway. It should be noted that historical aerial imagery from August 2014 potentially shows a liner on the bottom of the lower lagoon; however, the presence of this liner was not confirmed during the inspection. Before visiting the lagoons, Mr. Duff informed Mr. Kurano and I that a dairy employee went down to the lower lagoon and confirmed that the southeast side of the lower lagoon contained an overflow spillway. We visited the overflow spillway of the lower lagoon and observed algae growth and standing water in the spillway (refer to Photographs 28, and 31 through 33). While standing on the overflow spillway, which was saturated and coated in unstable muck, I estimated the freeboard underneath the lagoon's overflow spillway at approximately twelve inches (refer to Photograph 34). Facing southeast from the overflow spillway, I observed a clear flow pathway down a heavily vegetated conveyance channel that flowed to the southeast (refer to Photographs 35 and 36). Based on aerial imagery, this conveyance channels flows directly into Kaohaoha Gulch, approximately 100 feet southeast of the lower lagoon overflow spillway (refer to Figures 1 through 3). I was unable to hike down the conveyance channel due to unstable mucky conditions and thick vegetation (refer to Photograph 36).

Photograph 36. The channel downgradient of the lower lagoon overflow spillway was heavily vegetated; however, I observed clear channelization and a flow pathway toward Kaohaoha Gulch. Photo by A. D'Angelo; 12/14/16.
