**Subject: National Pollutant Discharge Elimination System (NPDES)
Concentrated Animal Feeding Operation (CAFO)
Villa Rose Egg Farm
Waialua, Island of Oahu, Hawaii**

**Hawaii Department of Health
 Clean Water Branch
 National Pollutant Discharge Elimination System (NPDES)
 Concentrated Animal Feeding Operation Inspection Report**

Inspection Report No. OA2833 **Announced:** Yes- <24-hour notice

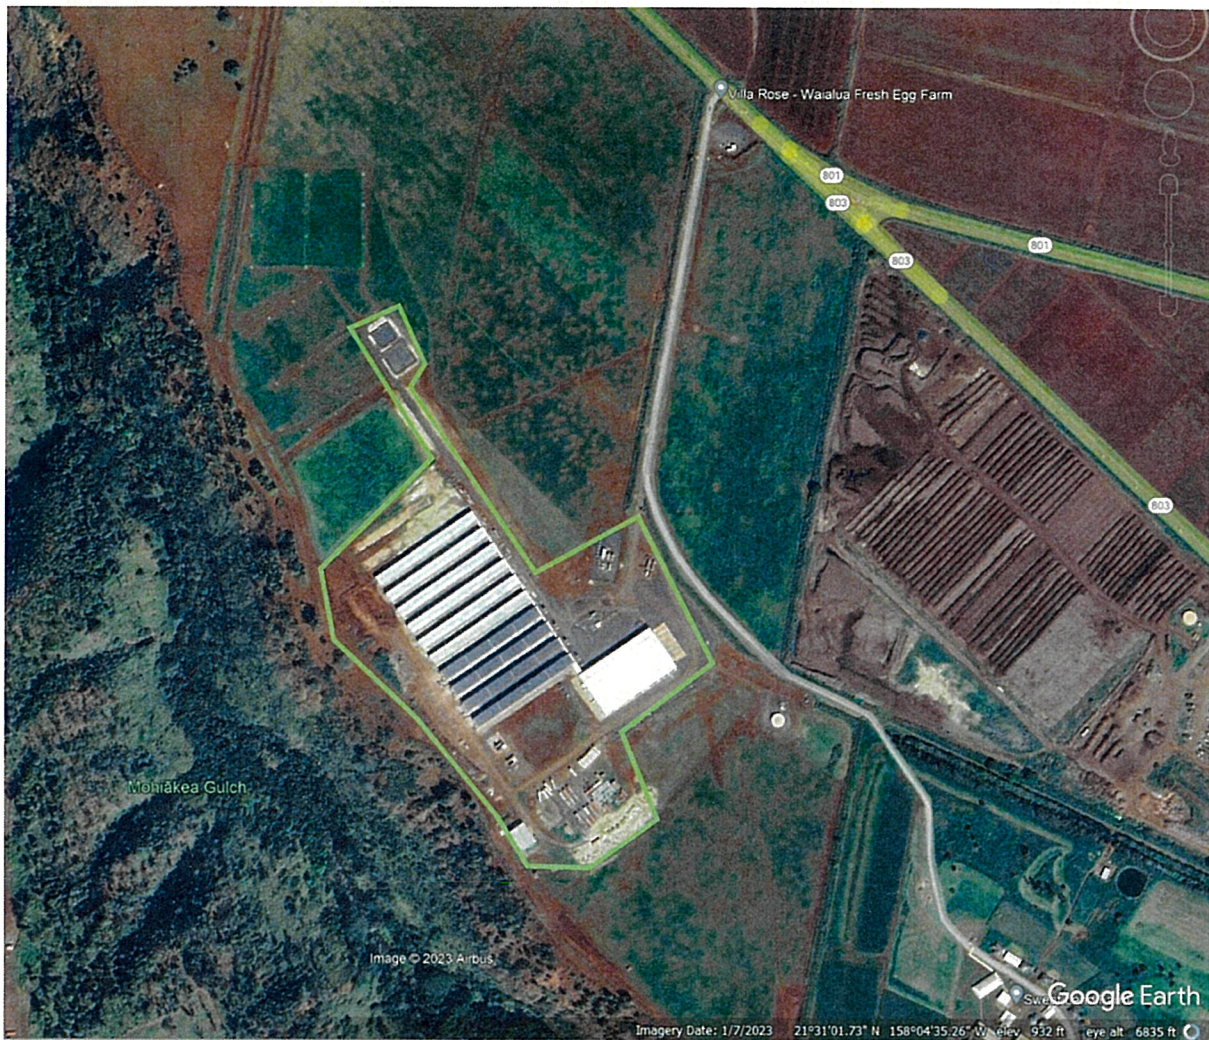
The Facility (Image 1) is located at street address 65-1001 Kaukonahua Road, Waialua, Hawaii 96791 (Attachment 2). Property Records indicate that the property is owned by Villa Rose, LLC, 318 acres and zoned for agriculture. According to S. Curry, the Facility produces chicken eggs for local distribution. A small stand at the entry to the Facility offers retail sales of eggs produced at the Facility.

Image 1: View of the Villa Rose Waialua Egg Farm (general outline in green). Image taken from Google Earth on 2/27/2023. Note: According to Facility representatives, the surrounding fields are not being used at the time of inspection.

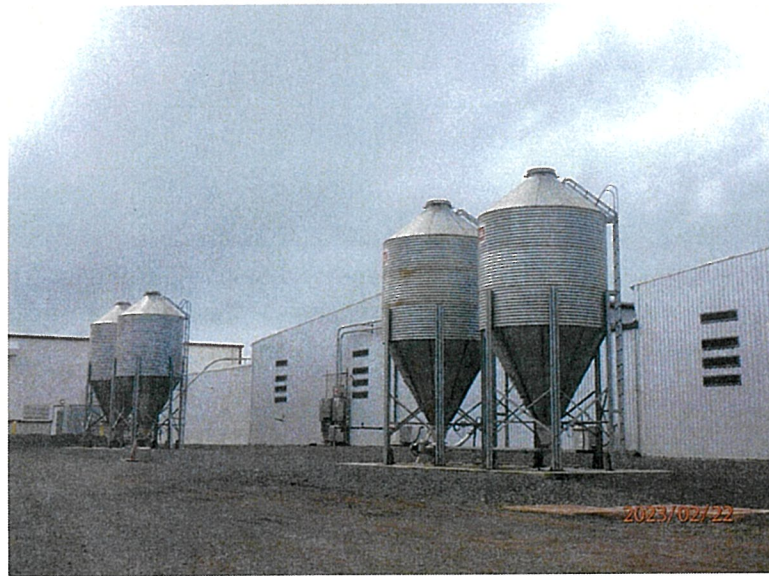
Photograph 2.

Description: View of the northeast side of two of the barns that are in operation. The barns are identical externally. The barns not in operation did not have hoppers pictured.

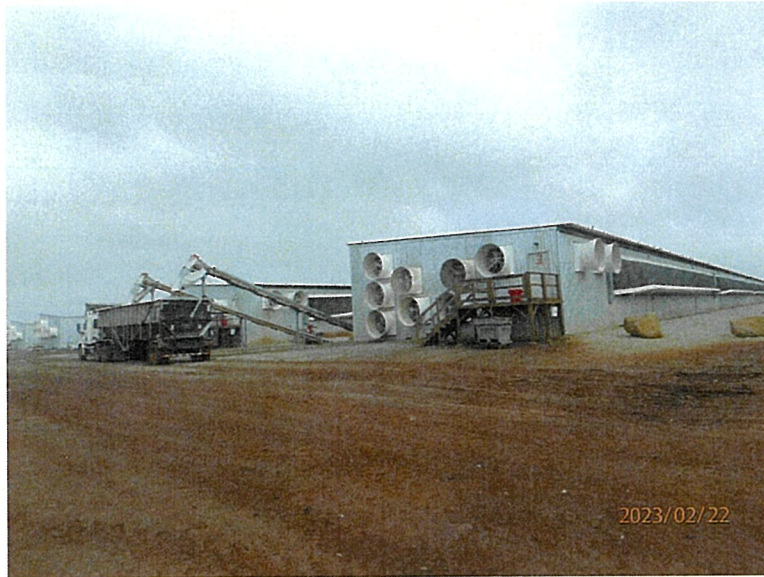
Photograph 3.

3. The Facility utilizes a dry manure handling system that relies on the moisture content of the manure being controlled through the use of mechanical ventilation systems within the barns. Dry manure is removed from the barns through a conveyor system that loads a large capacity truck (Photograph 3). The Truck transports the dry manure to a barn currently not being used for egg production. The manure is stored in the barn (Photograph 4) and is turned and kept dry in what appeared to be a well-ventilated structure. The Facility Representatives estimates approximately 10 tons of manure is generated per day.

Description: View of the southwest side two of the barns in operation. The southwest sides had exhaust fans installed and conveyor belts used to remove and load the manure generated in each barn.

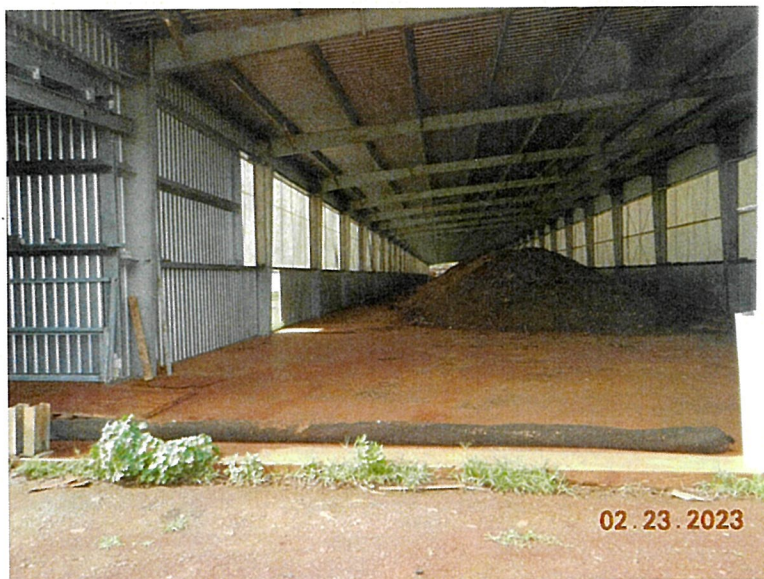
Photograph 4.

Description: View of the Facility's manure stockpile. The manure is stored in an enclosed barn currently not in use for egg production.

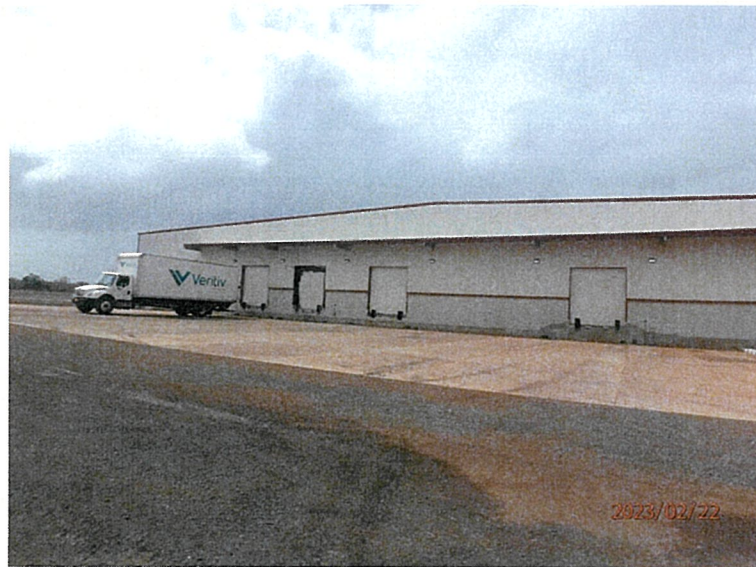
Photograph 5.

Description: View of the Facility's production and shipping building

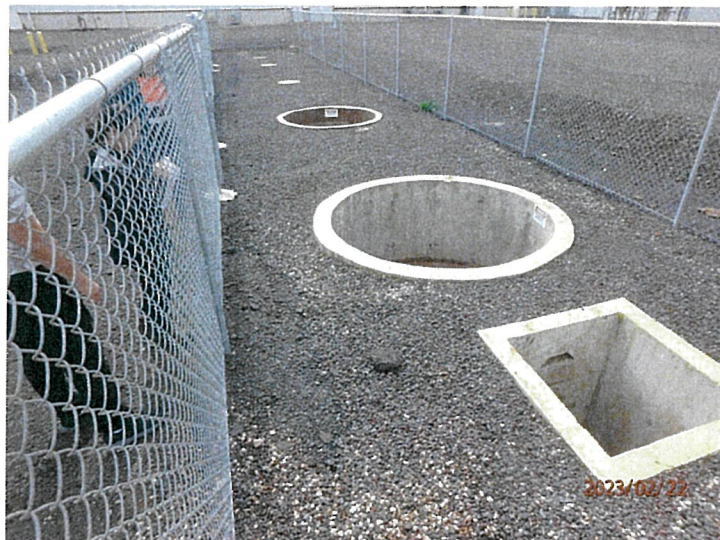
Photograph 6.

9. The Facility treats and disposes of its wastewater through operation and use of an onsite wastewater system. The onsite wastewater system includes a septic tank component (Photograph 6), subsurface contact with media (Photograph 7 and 8), and final disposal through a subsurface drip field. The flow meter for the wastewater system was reading an instantaneous flow of 5 gallons per minute (gpm) at the time of inspection.

Description: View of the Facility's wastewater system (septic segment). Bulky solids are removed from the wastewater through a septic system before additional treatment on the north side of the Facility.

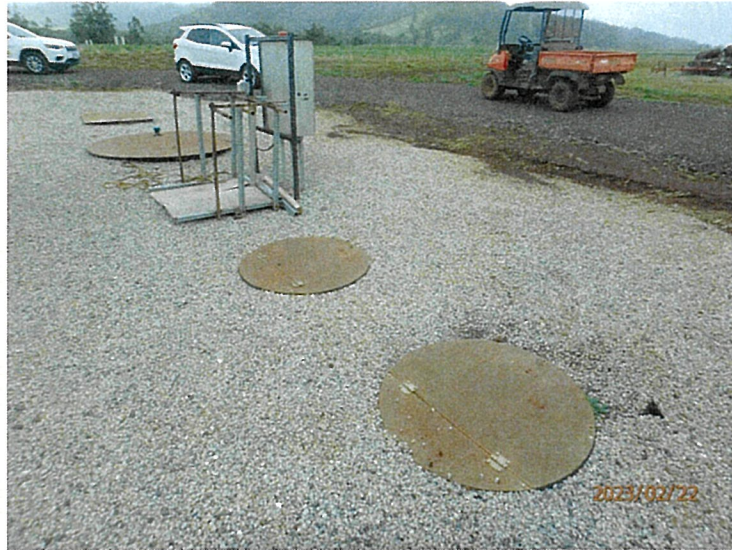
Photograph 7.

Description: View of the Facility's subsurface treatment and disposal system on the north side of the facility. Wastewater is filtered through underground media prior to disposal through infiltration/irrigation.

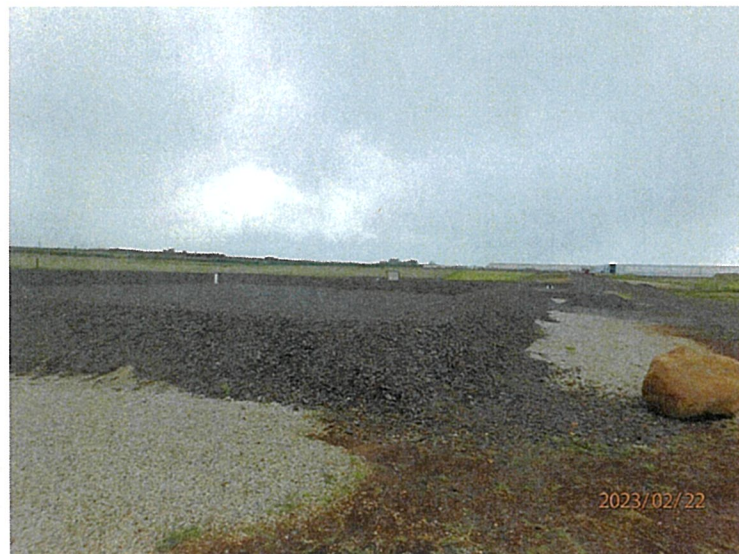
Photograph 8.

Description: View of the wastewater treatment system's subsurface media beds used for additional treatment.

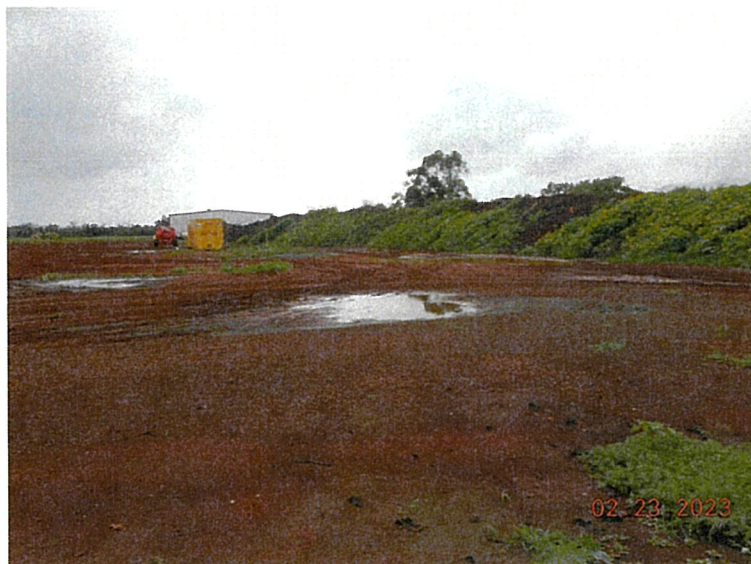
Photograph 9.

11. The area of highest risk for storm water discharge appeared to be the west side of the Facility. The Mohiakea Gulch is located immediately west of the Facility. However, it appears that large earthen berms in place between the Facility's production areas and Mohiakea Gulch (Photographs 9 and 10) contain storm water contacting production areas of the Facility. Note: The perimeter on the Mohiakea Gulch was *not* fully inspected at the time of inspection. It is the responsibility of the Facility to determine whether storm water discharges from the production area occur or not.

Description: View of the large earthen berms on the west perimeter of the Facility facing south. Storm water that contacts the production area pools in the area between the berm and the nearby Mohiakea Gulch.

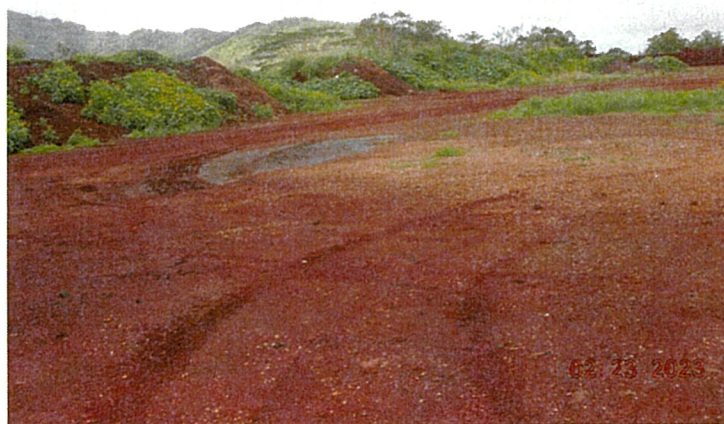
Photograph 10.

Description: View of the earthen berm on the west side of the Facility facing north. No evidence of storm water discharge from the Facility through the berm was observed at the time of inspection.
