**Concentrated Animal Feeding Operation
NPDES Inspection Report**
Facility Name: Big Island Dairy
NPDES Permit No.: Not Permitted

Date and Time: December 14, 2016 **Entry:** 10:00 a.m. **Exit:** 4:45 p.m.

Facility Name: Big Island Dairy

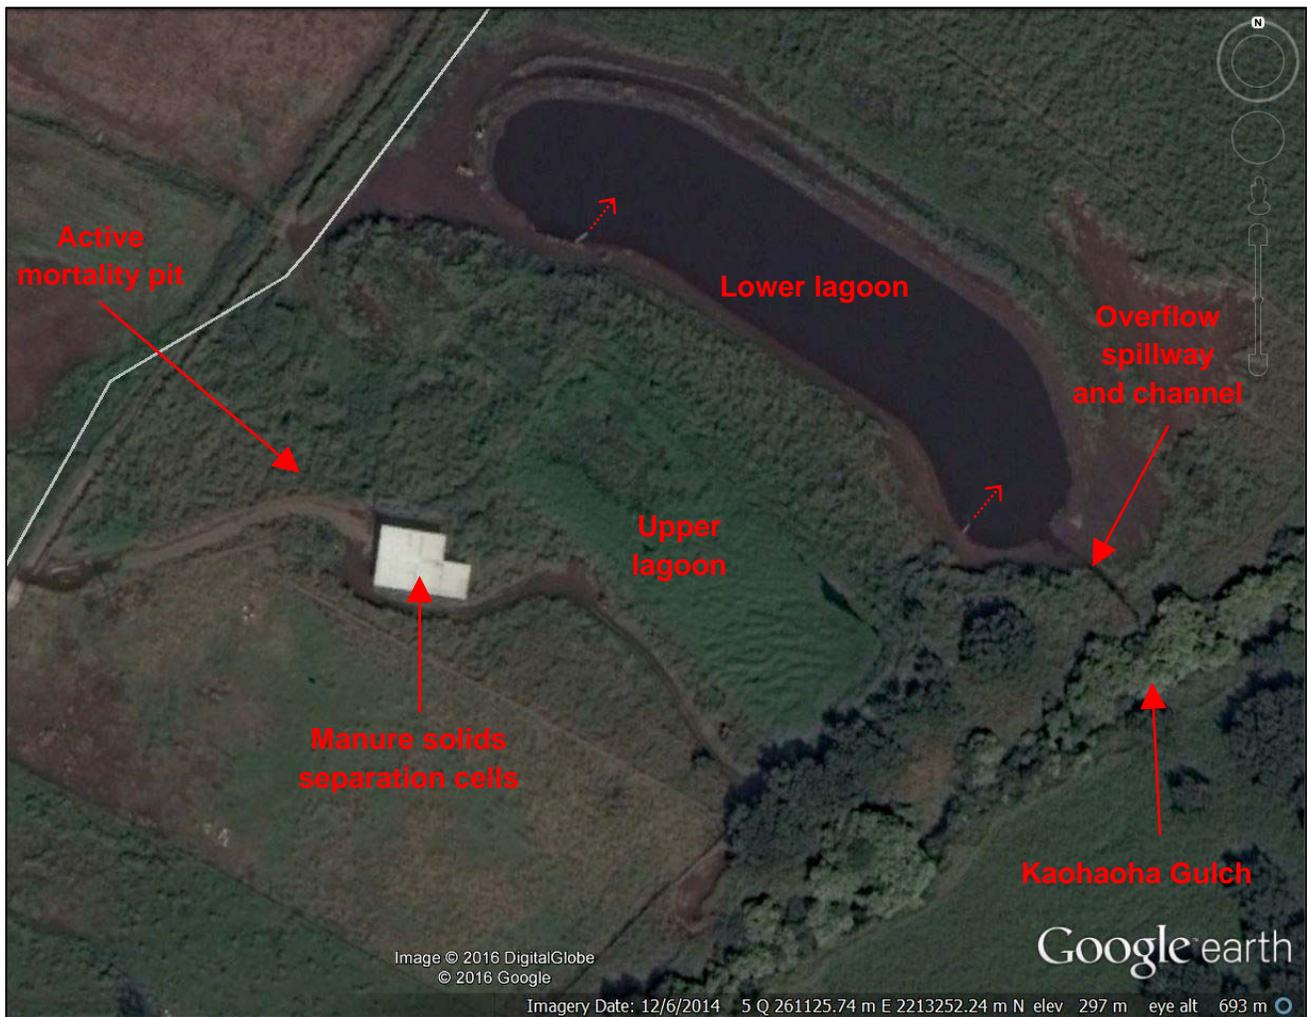
- Proximity of the upper and lower lagoons to Kaohaoha Gulch (refer to Figures 2 and 3),
- Presence of the lower lagoon overflow spillway and conveyance channel into Kaohaoha Gulch (refer to Photographs 31 through 36),
- Minimal freeboard available in the lower lagoon (refer to Photographs 31 through 34),

Figure 2. *GoogleEarth* aerial image of the BID manure separation cells and wastewater lagoons, imagery date December 6, 2014. The red arrows and callouts are approximate location estimations of Facility features observed during the inspection, described in the report, and shown in the Photograph Log.

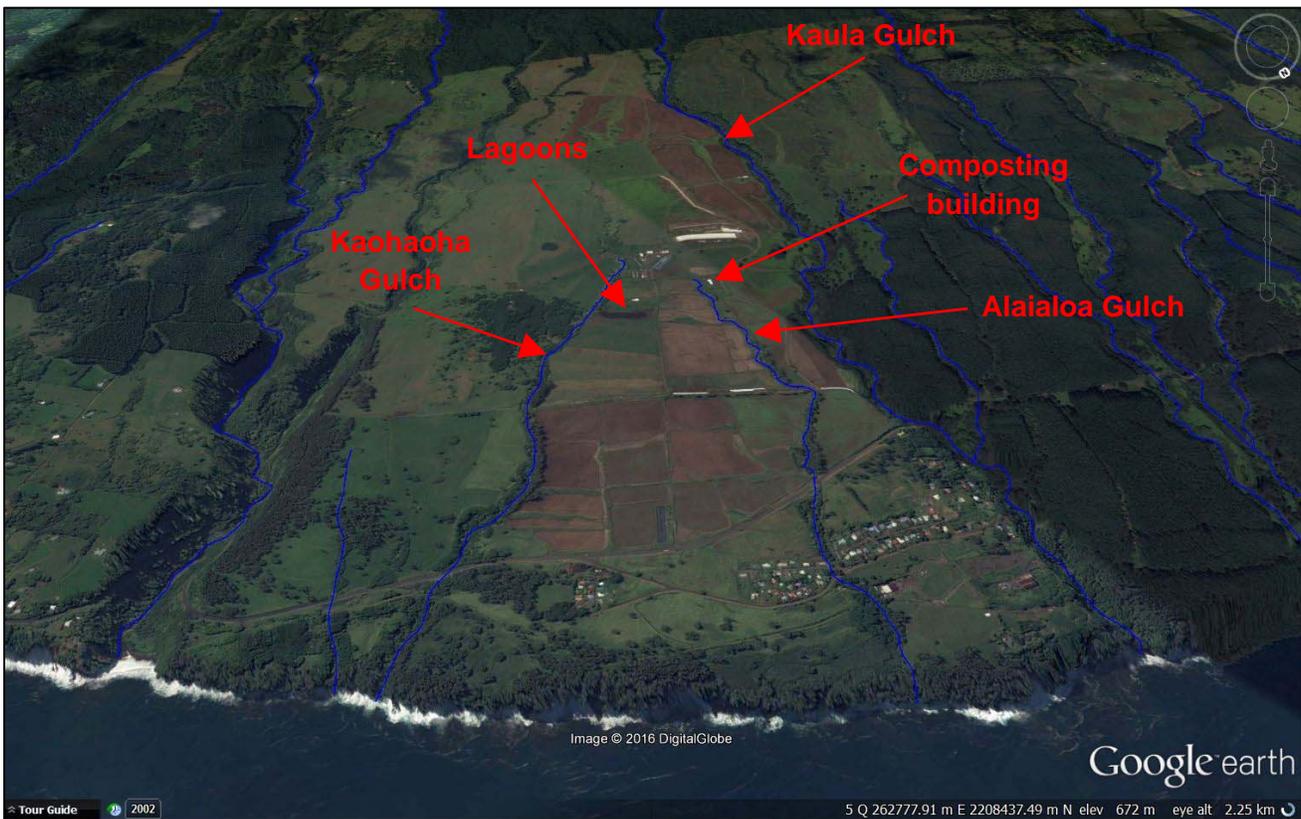
2. During the inspection, I observed the potential for the Facility to discharge pollutants to Kaohaoha Gulch, an identified State water and water of the U.S. As part of the Facility tour, I inspected the new, lower 2.5 million-gallon wastewater lagoon, including its southeast overflow spillway (refer to Photographs 26 through 28, and 31 through 33). While standing on the overflow spillway, which was saturated and coated in unstable muck and standing water, I estimated the freeboard underneath the lagoon's overflow spillway at approximately twelve inches (refer to Photograph 34). The lower lagoon was not equipped with a depth marker. Facing southeast from the overflow spillway, I observed a clear flow pathway down a heavily vegetated conveyance channel that flowed from the lagoon to the southeast (refer to Photographs 35 and 36). Based on aerial imagery, this conveyance channel flows directly into Kaohaoha Gulch, approximately 100 feet southeast of the lower lagoon overflow spillway (refer to Figures 1 through 3).

Figure 3. *GoogleEarth* aerial image, oriented southwest, of BID and Ookala, HI, imagery date December 6, 2014. The blue lines designate streams identified on the EPA My Waters Mapper application. The red arrows and callouts identify the Facility’s main three receiving waters: Kaohaoha Gulch, Alaiialoa Gulch, and Kaula Gulch, as well as the lagoons located adjacent to Kaohaoha Gulch and manure composting building near the origin of Alaiialoa Gulch.

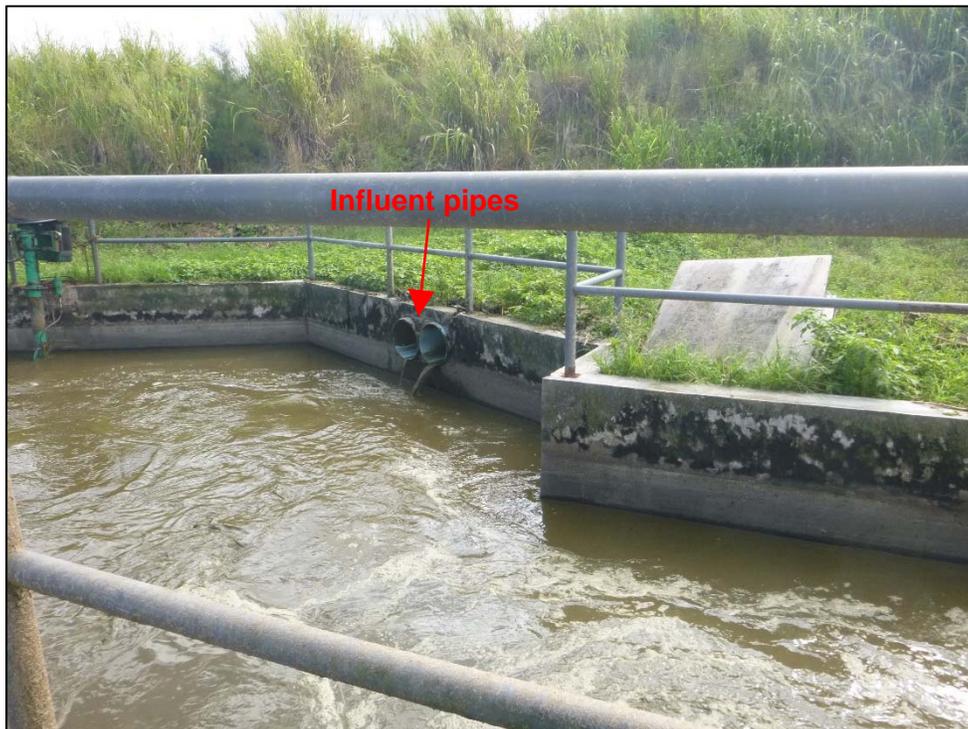
- Steep topography of the BID property, and
 - High annual rainfall amount.
3. During the inspection, I observed a potential for pollutants from the Facility's manure composting operations to contaminate storm water runoff. The manure composting building is located near the origin of Alaialoa Gulch (refer to Figure 3). Storm water runoff from the manure composting building, and uncovered concrete cow bedding loading area appears to most likely flow into the upgradient reach of Alaialoa Gulch. As previously stated, during the visit to the manure composting building, I observed a tractor actively loading a trailer with cow bedding (refer to Photographs 15 through 19, and 21).

Photograph 16. View of the manure composting building collection pit influent pipes. Photo by A. D'Angelo; 12/14/16.

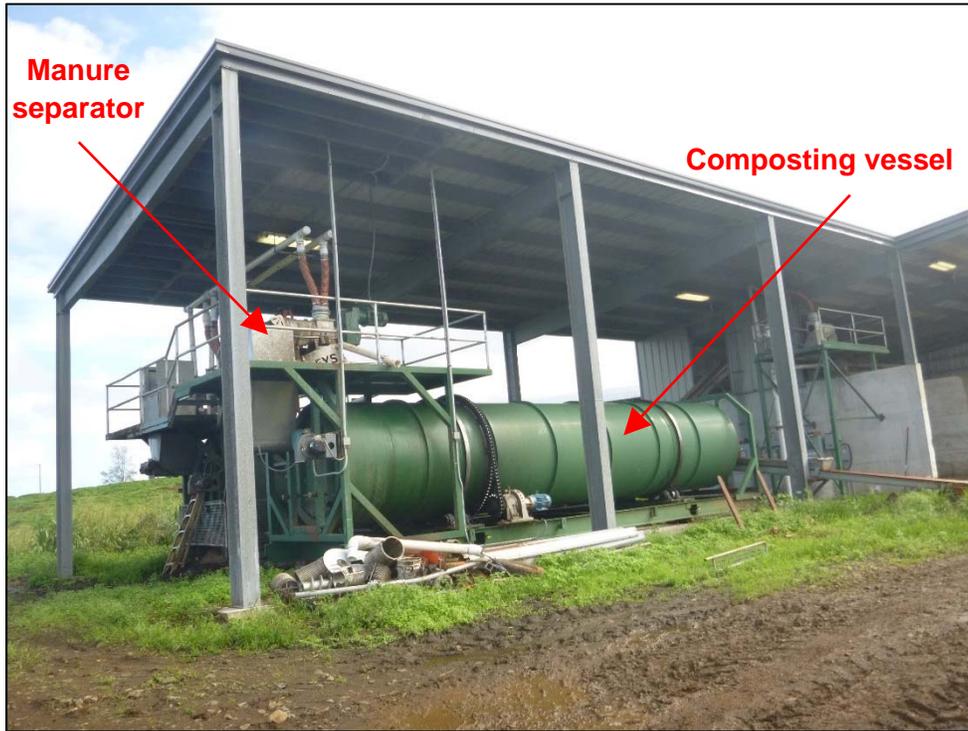
Photograph 17. View of the Facility's manure composting building which included two manure separator units, and two composting digester vessels. Photo by A. D'Angelo; 12/14/16.

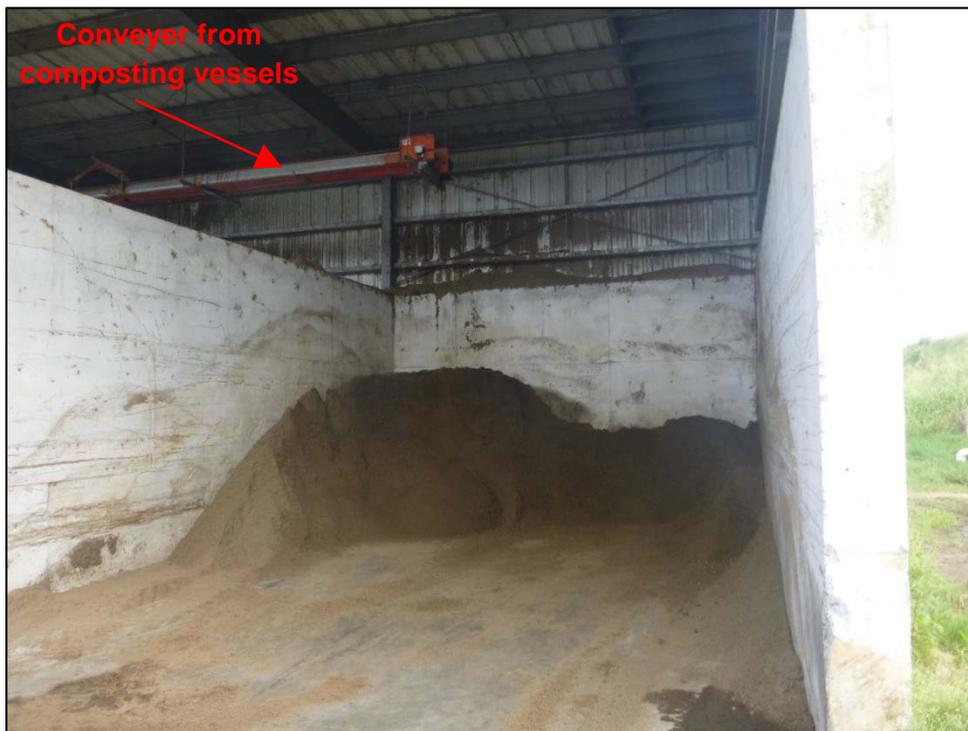
the vessels is then mechanically conveyed into a covered composted manure stockpile stall (refer to Photograph 18). During the visit to the manure composting building, I observed a tractor actively loading a trailer with cow bedding (refer to Photograph 19).

Photograph 18. A conveyor belt on the back end of the composting vessels conveys composted manure (i.e., cow bedding) into a covered stockpile stall. Photo by A. D'Angelo; 12/14/16.

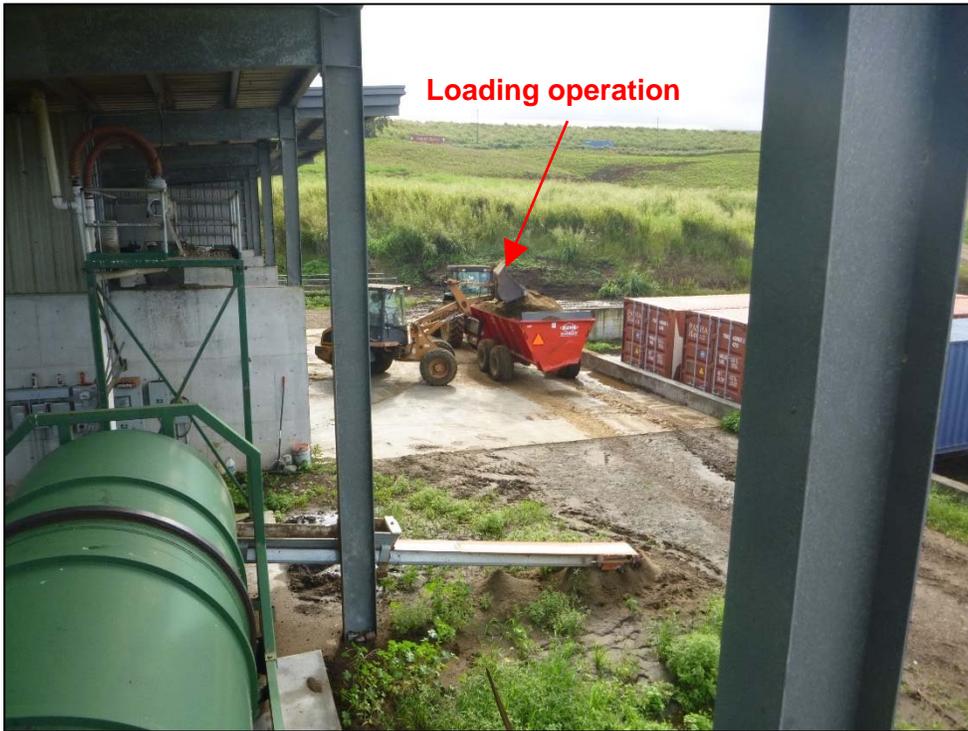
Photograph 19. View of BID staff actively loading cow bedding from the covered bedding stockpile stall into a trailer. Photo by A. D'Angelo; 12/14/16.

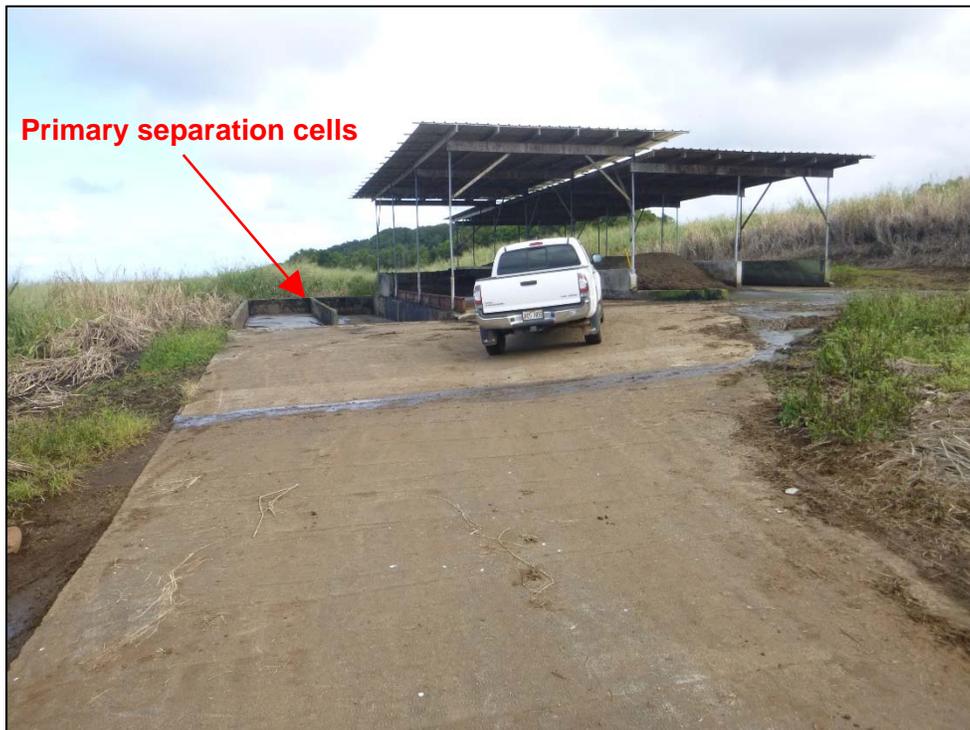
Photograph 22. View, facing east, of the Facility’s manure solids separation cells located adjacent to the upper lagoon (refer to Figure 2). The uncovered cells on the left serve as the primary cells and liquid waste discharge points. Photo by A. D’Angelo; 12/14/16.

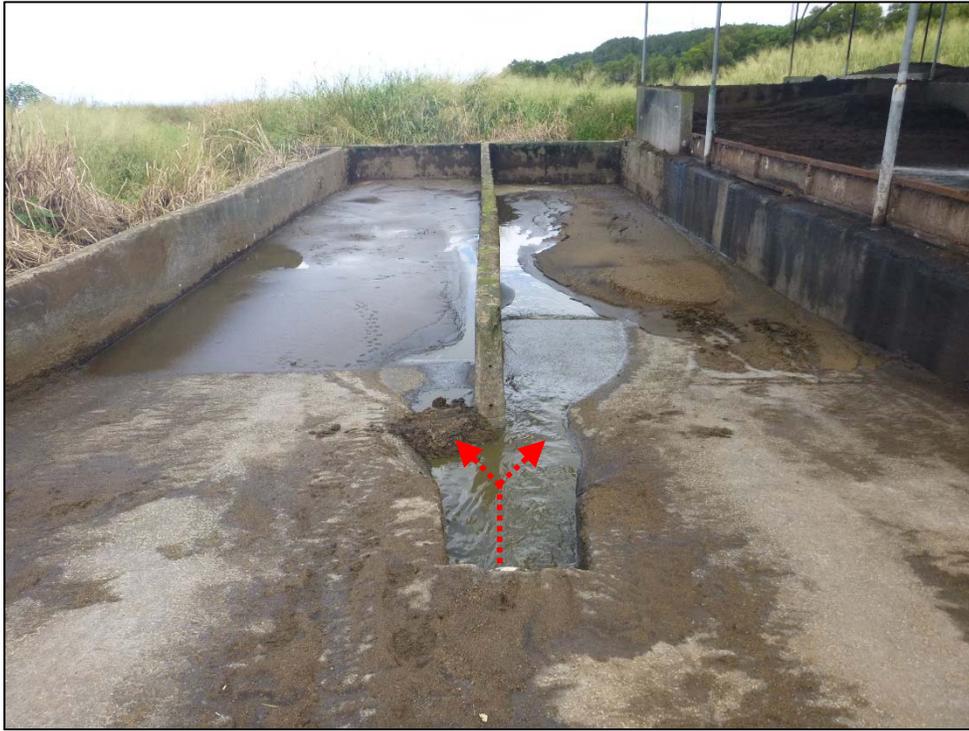
Photograph 23. View of flow from the manure composting collection pit entering the primary cells of the manure solids separation cells shown in Photograph 22. Photo by A. D'Angelo; 12/14/16.

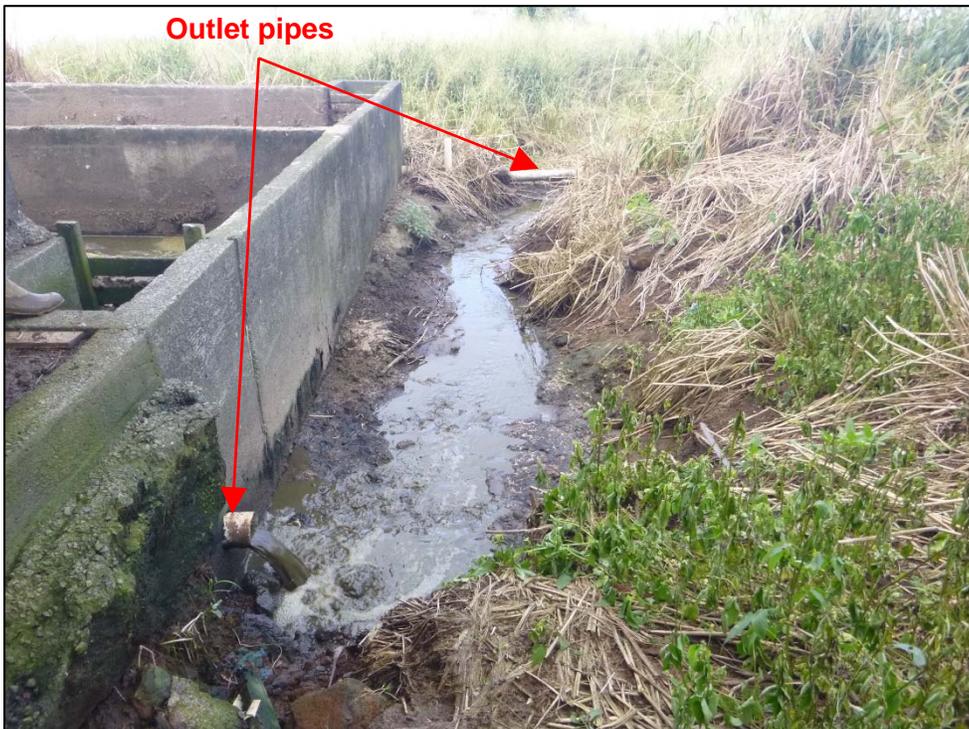
Photograph 24. View of the two pipes that drain separated liquid from the manure solids separation cells. Liquid from the cells surface flows, via an earthen conveyance channel, into the northwest side of the upper lagoon. Photo by A. D'Angelo; 12/14/16.

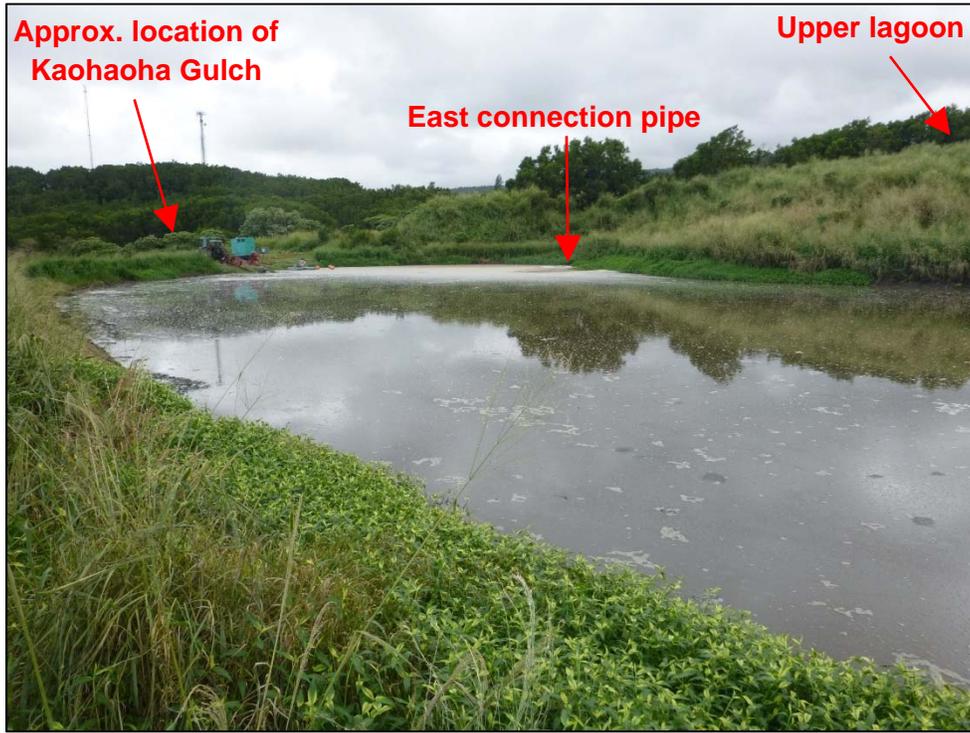
Additionally, the lower lagoon contained a floating agitator unit which was used to agitate and suspend manure solids in the lower lagoon prior to engaging the draw pumping system for irrigation (refer to Photograph 28). Due to the minimal freeboard in the lower lagoon, there exists a possibility of spillover from lagoon into the overflow spillway due to agitation activities that may occur near the overflow spillway.

Photograph 27. View, facing southeast, of the lower lagoon. I observed a floating agitator unit, draw pumping system, and overflow spillway on the southeast side of the lagoon. Photo by A. D’Angelo; 12/14/16.

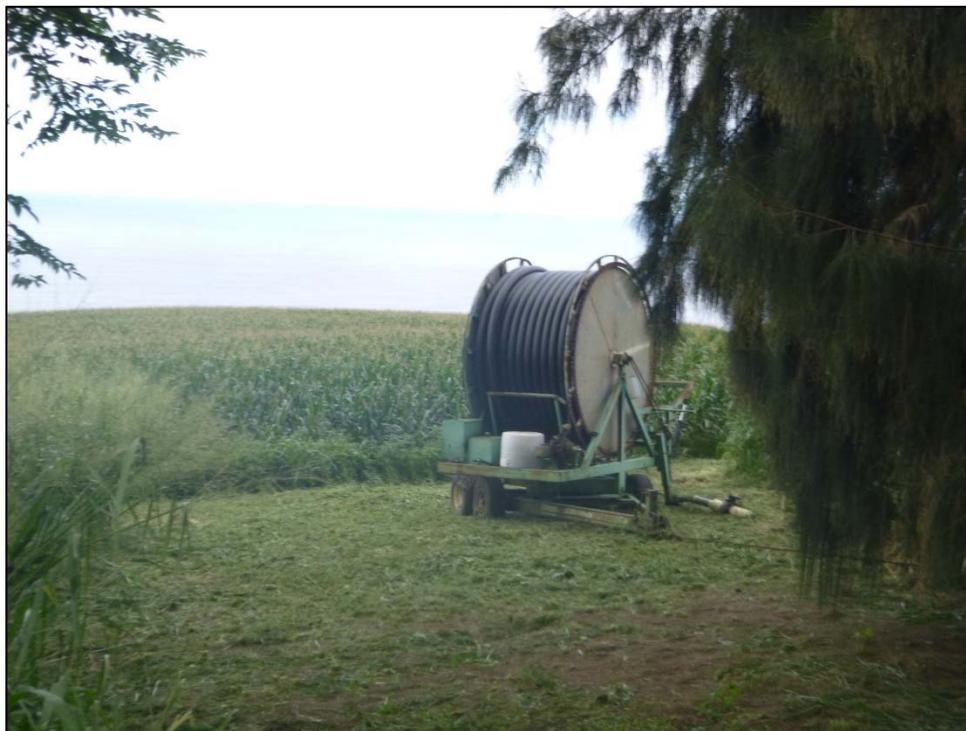
As previously stated, the contents of the lower lagoon are used to irrigate and fertilize the Facility's low elevation, high yielding croplands. Additionally, Mr. Duff stated that the manure solids separated from the manure separation cell system are directly land applied on croplands as additional fertilizer. During the Facility tour, we visited the lower croplands to view the airstrip heifer sheds, low elevation irrigated croplands, and one of the retractable irrigation sprinkle systems (refer to Photograph 30).

Photograph 30. View of one of the Facility's retractable irrigation distribution equipment which receives flow from the lower lagoon draw pumping system. Photo by A. D'Angelo; 12/14/16.

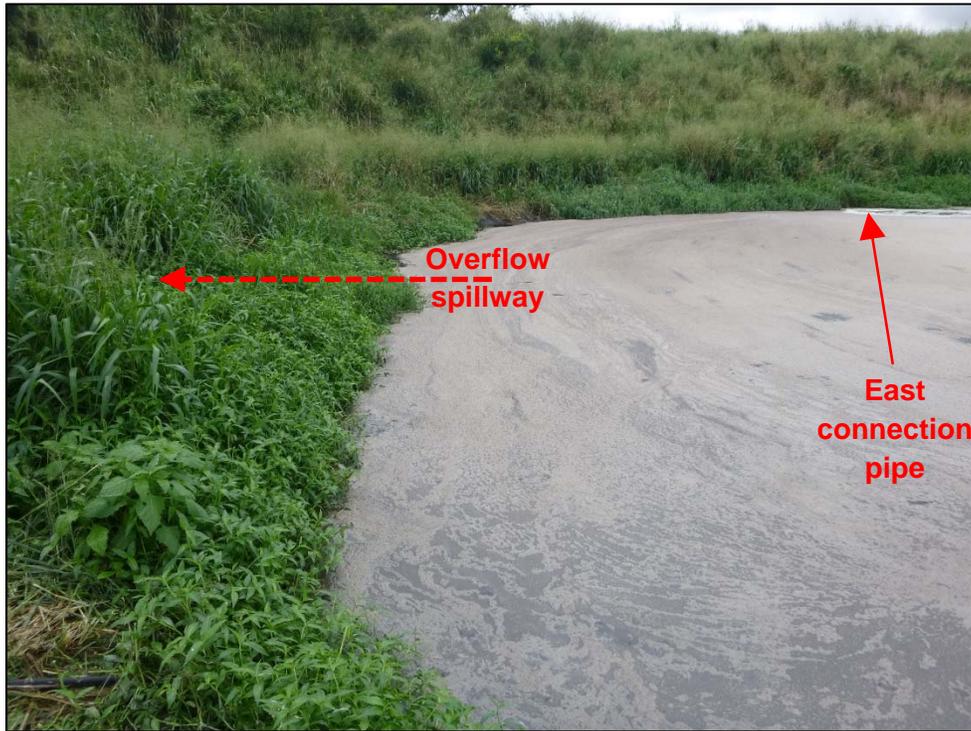
Photograph 31. View, facing south, of the approximate location of the lower lagoon overflow spillway. Photo by A. D'Angelo; 12/14/16.
